# A Guide to County Hall Building Stone

## Welcome to County Hall

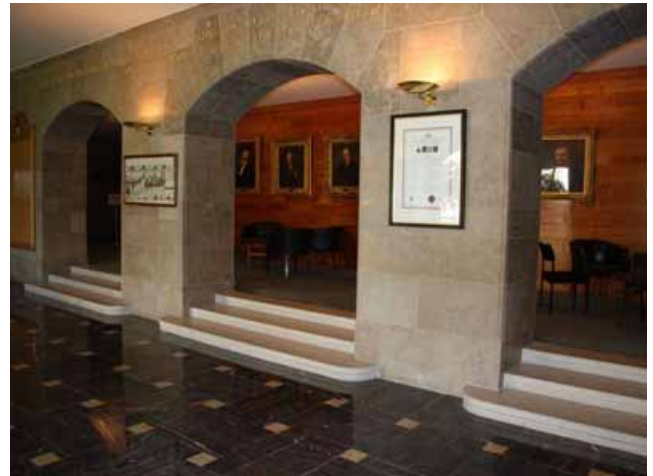
## Age of County Hall Building Stones

- A** Purbeck Stone
- B** Portland Stone
- C** Douling Stone
- D** Heavitree Breccias & Exeter Volcanics
- E** Dartmoor Granites, Greenstone & Yorkstone
- F** Ashburton Marble
- G** Cambrian Slates

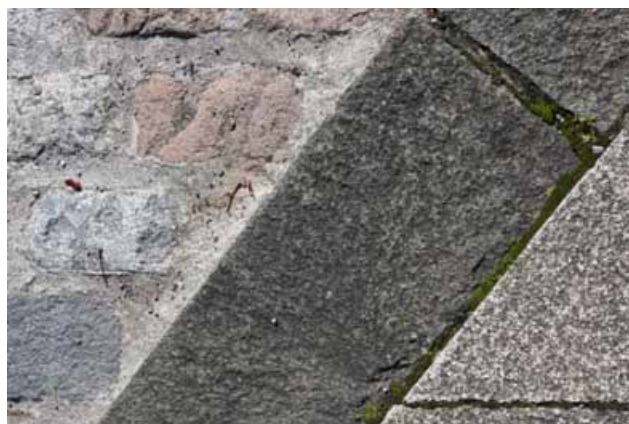
## 1 Walkway in front of the Visitor Car Park

Notice the granite setts across the road near Lucombe House (top left in photo). **Granite** is an igneous rock formed by partial melting deep within the Earth's crust. The magma was less dense than the surrounding rocks so intruded upwards into the surrounding country rocks above. The magma then cooled slowly, allowing the minerals to form large crystals. Note the large white **alkaline feldspar** crystals, black **biotite mica** flecks, and glassy grey **quartz**. Notice also that there are finely crystalline red-pink blocks. These are composed of rhyolite – a similarly quartz and feldspar rich rock to the granite, but one which cooled very rapidly. The black blocks are **dolerite** (similar to those described below).

**Greenstone** kerbs (pictured diagonally through centre of photo): Look out for the dark kerbstones lining the pavements here and around much of the County Hall grounds. These are altered **dolerite** - igneous rocks formed from basic magma, which didn't reach the surface to form a **basalt lava**. The word 'greenstone' is a local name for this rock, which most likely came from the Teign Valley. If you can get up close to this you should be able to spot needles of white **plagioclase feldspar** crystals and dark-coloured **pyroxene**.

Paving slabs (bottom right in photo): These are composite paving slabs, not a true 'building stone', usually formed from a mixture of crushed-up rocks and concrete.

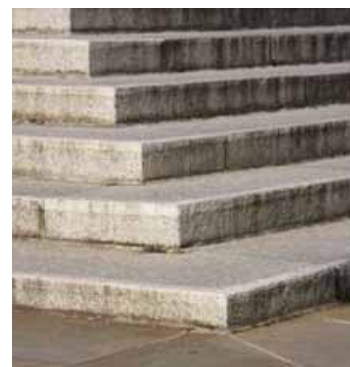
## 2 Main Entrance Steps

Find the **granite** steps. As well as the previously mentioned granite setts used as paving, here we see light-coloured granite slabs used for most of the steps. You should be able to see the same sorts of minerals as previously listed in

these rocks, however their colour and texture is much more uniform. The typical light colour of granite is due to its **acid** composition. It contains large amounts of **feldspar** and **quartz**. Look really closely and find small black needle-like crystals throughout the granite – these are **tourmaline**, a mineral characteristic of southwest granites. Although we don't know the exact quarry location, it is likely that these slabs came from Cornwall or Dartmoor.

Look for **Yorkstone** paving and steps. These are the dusty grey or light brown coloured stones making up one of the steps towards the main entrance. These are a type of sandstone (a sedimentary rock) known for its hard-wearing qualities. It has tightly packed grains of quartz, feldspars, and micas, with a natural cement of reddy brown iron oxide and silica that binds the sediment together making it strong. If you look closely, erosion from people walking over the stone has brought out small-scale structures on the surface (cross-bedding). This is not to be confused with the groove markings that have been made on the surface of the rock when it was cut, to give extra grip. It is likely that this was quarried in Yorkshire, although the exact quarry location is unknown

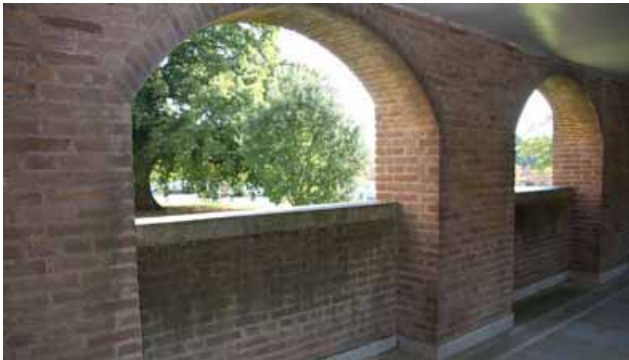
### 3 Walkway

Here there is more **Yorkstone** paving, **granite** gutters and window ledges around the red brick structures. Most of the walkways and pavements around the main County Hall buildings consist of some combination of these stones, so look out for them as you walk around.

This is a good opportunity to take a closer look at the bricks, which are the most extensively used building material at County Hall. These bricks are particularly interesting for their special shape, with a thin (two inch) thickness. Historic documents record the handmade bricks as being sourced from Leicestershire and are described as a 'golden brown lbstock brick'.

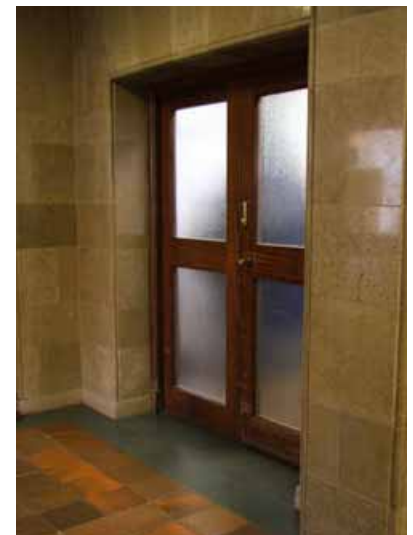
### 4 Main Reception

Go into main reception and look down at the floor. Notice the red-orange floor tiles lined at the edges of the room by a black stone.

The red tiles are Welsh Quarry tiles from Wrexham, Clwyd, made from natural clay (**Etruria Marl**) which has been quarried at Ruabon since 1878 and fired in kilns.

The black stone edging the room is a **welded tuff** or **'ignimbrite'**. To form this rock, hot material was blasted out from within a magma chamber and a caldera of a volcano. This blast resulted in powerful pyroclastic flows heated to hundreds of degrees Celsius that burnt anything in their path. Bedrocks were sometimes ripped up off the ground and included in the flow. The fast flow carried ash, lava and fragmented rocks which were deposited on the flanks of the volcano and surrounding land. The flows can result in bedding, laminations and swirled structures. After deposition, the hot ash was compacted and welded together becoming hard and resistant. It is possible that later lava flows and regional metamorphism have caused continued heating, recrystallising the tuff to what we see today. The white streaked quartz veins were formed later through cracking of the rock, with deposition of silica in the cracks.

Look out for the polished walls of **Purbeck Limestone** used as wall tiles here, along the corridor in front of you and in much of the interior of the main building and near the Council Chamber. This is thought to be **'Thornback'** – a local name for this cream shelly limestone, which is part of the formation that is used for Purbeck building stones. It was formed in warm shallow freshwater or brackish lagoons roughly 140 million years ago and in this case is crammed with fossils; bivalves such as **Corbula** (small tear-drop shaped shells, usually white) and **Neomiodon**, oysters including **Praeexogyra contorta**, along with gastropods. Crocodile and turtle bones have been recovered in some of these rocks!

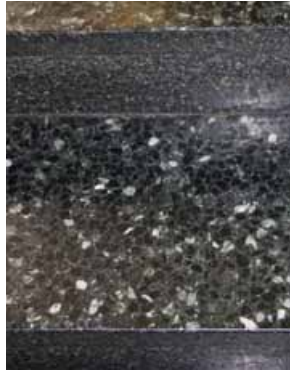
## 5 Stairways

These consist of black **terrazzo** – a manmade composite material made from crushed black, white, green, and red **marble** chips in a black epoxy binder. Composed of **calcium carbonate**, marble is a broad term applied to a variety of recrystallised limestones. The colour variations are often caused by metallic impurities in the rock. Look out for the white **calcite** veining across many of the chippings.

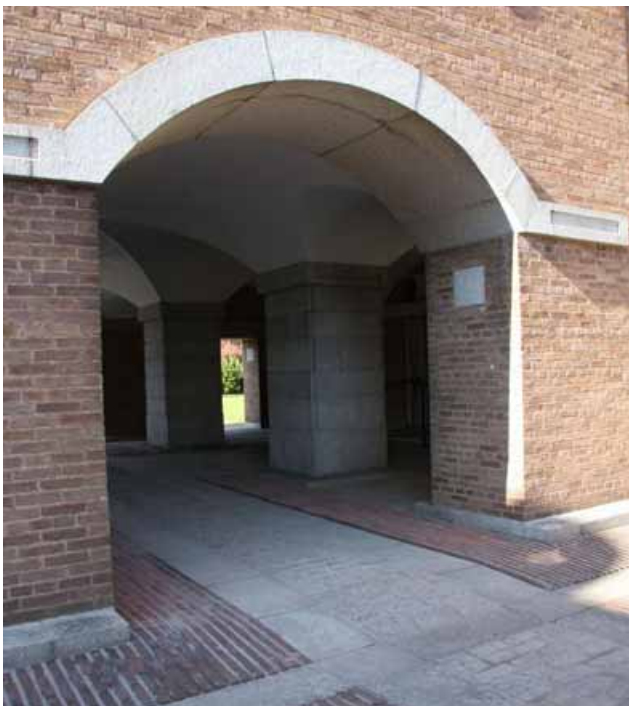
## 6 The Great Gateway

Notice the huge **granite** pillars. These are the same granite as used for the steps to main reception and the window lintels. On closer inspection you should see the usual quartz, black biotite mica, larger white alkaline feldspar (here **orthoclase feldspar**), and a background of poorly formed whitish **plagioclase feldspar**. The white orthoclase feldspar crystals found here are large and rectangular shaped (termed phenocrysts). These probably crystallised first in the intruding magma and had enough space to develop a good crystal structure. Look closely at them moving from side-to-side and you should find that one half of the crystal will glint in the light, while the other side remains dull. This is due to their twinning – two sides of the same crystal, grown in different orientations. Look out also for brown halos around the black flecks of **biotite**. The iron content of these decomposes and causes this staining to the surrounding rock.

Notice again the walkways with their **granite** and **rhyolite** bricks, **Yorkstone** paving, and **Greenstone** kerbs...

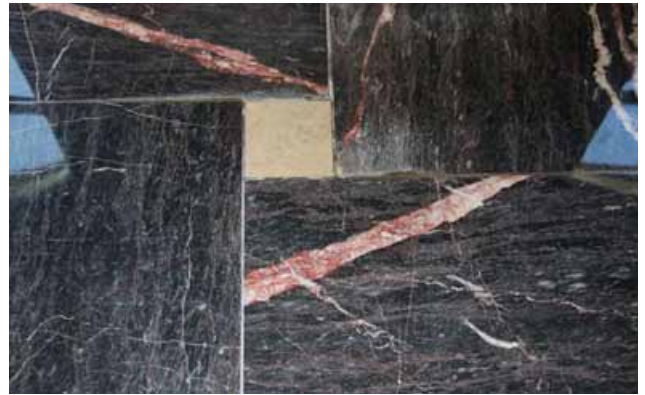
## 7 Into the Antechamber

Enter this building and notice how lavishly it has been decorated. A Purbeck Limestone called **Thornback** clads the walls and the floor is covered in the most spectacular black, white, and red rock. This is **Ashburton Marble**.

Formed roughly 370 million years ago, the Ashburton Marble is from a time when Devon was situated close to the equator. This Devonian limestone is a fine lime-based mud with abundant fossils found throughout. It was formed in a shallow tropical sea with neighbouring coral shelves, much like the Caribbean today. Look closely, you should see oval-shaped white fossils – these are individual corals which look like cartwheels. Also you can see examples of **tabulate** and **rugose** corals here, both of which are extinct forms.

**Stromatoporoids** can easily be found, these are a type of fossil sponge. There are also **algal patches** (which look like very fine nets) and **brachiopods** (a marine shell). After deposition, squeezing of the land caused faulting and thrusting of the rocks. Once the compressional period had ended the rock extended and lens-shaped cracks formed and were infilled with whitish calcite, which can be seen across the floor tiles (known as **en echelon veins**). This outstanding rock was extensively quarried from sites such as the Linhay Hill Quarry near Ashburton.

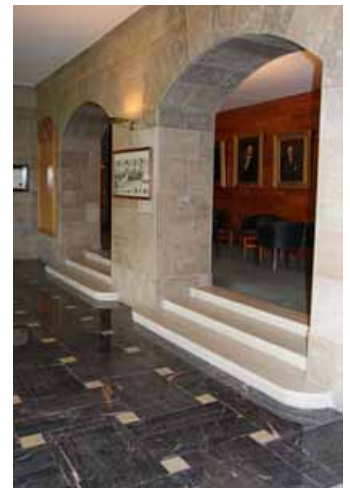
**Portland Freestone** makes up the steps and small square tiles between the Ashburton Marble. A light coloured limestone, this looks quite different from the **Purbeck Limestone** wall cladding above it, and is older. As sea levels shallowed roughly 145 million years ago in the Upper Jurassic, marine limestones began to be deposited in this tropical warm water. Shelly fossils were preserved including **gastropods** and **bivalves** such as oysters. These shells are much less numerous in comparison to the Purbeck Limestone. **Portland Stone** is

characteristically **oolitic**. **Ooids** are small (<2mm) spherical grains built up from layers of precipitated calcium carbonate. The layers formed around a sand grain or shell fragment nucleus which was rolled around on the seafloor due to currents and waves, coating in needles of calcite – great quantities of these are currently forming off the Bahamas. This white stone became fashionable throughout the country when Sir Christopher Wren used it to rebuild St Paul's Cathedral after the Great Fire of London.

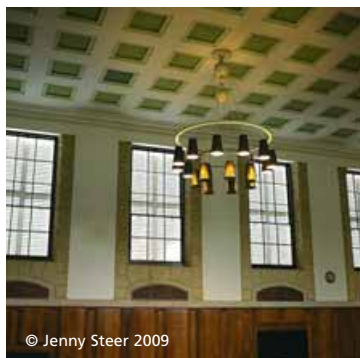
## 8 The Council Chamber

For such a grand room, this has surprisingly only one visible building stone on show – **Douling Stone**. This **inferior oolite** was sourced from just east of Shepton Mallet in the Douling Quarry, having been used historically since the Middle Ages and in famous buildings such as Wells Cathedral and Glastonbury Abbey. Older than both Portland and Purbeck stones, this was formed in the Early Jurassic when sea levels were rising. The flooding of the land in the region of today's Mendips effectively made them into islands and it was near these ancient shores that this shell-rich limestone was formed. It's difficult to closely view this as it's so high up on the walls, but if you could you would see fossils including **brachiopods**, **bivalves**, **ammonoids**, and sea urchins (**echinoids**).

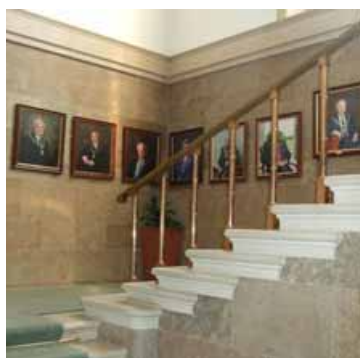
## 9 The Grand Stairs

Follow the corridor towards the Grand Stairway. Notice on your way the large **granite** commemorative stone inscribed and laid at the base of the back wall. This is a similar granite used for the pillars in the Great Gateway.

As always, the walls are clad with **Thornback** (a Purbeck Limestone) and the steps are of the noticeably different **Portland Freestone**. Following the stairs upwards, notice that there is a third limestone used around the windows, doorframes, and lining the walls above the Purbeck Limestone. This is **Spangle** – a local name for this coarse grained fossiliferous grey limestone quarried from St Aldhelm's Quarry in Dorset. This rock type occurs in conjunction with both the Portland and Purbeck beds. Notice the fossils it contains – there are some excellent cross-sections through **oysters** and **stromatoproids**.

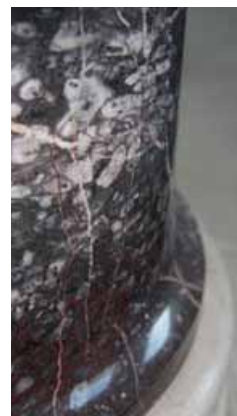
At the top of the stairs, there are two beautiful columns of polished **Ashburton Marble**. This is another opportunity to look closely for the fossils mentioned previously, and for a three dimensional view of the rock. The columns are capped at the top and base by turned **Portland Freestone**. Ashburton Marble was also used for the fireplace in the Roborough and Chairman's Rooms.

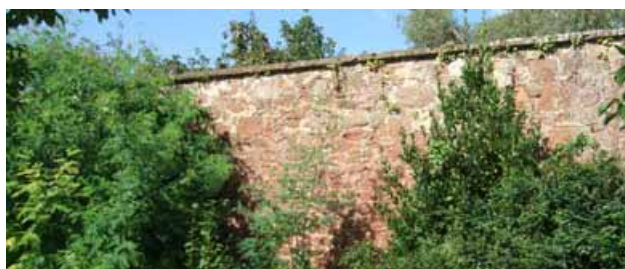
## 10 County Hall Boundary Wall

Exit the buildings and follow pavements which are mostly made from **Yorkstone** and lined with **Greenstone**. Find the wall behind the road north of County Hall, which pre-dates the construction of the buildings. This bright red construction is unmistakable through the garden shrubs and can also be found lining the pavements and roads down Matford Lane. Similar walls are easily sighted around Exeter Cathedral.

The wall seems to have been built out of reclaimed blocks from the local area along with locally quarried material. The characteristically red-brown rock is a **Permian breccia** quarried from Heavitree Quarry in Exeter itself. When these rocks were formed, Devon was experiencing hot arid conditions stricken with flash flooding across this desert. These would rip up clasts from sediments and bedrock they flowed over and it was these large angular pebbles that make up the rock between coarse sandy grains. The matrix and cement that glues the rock together is red because of its high iron oxide content (particularly **haematite**). Purple-grey **Exeter Volcanics** are also present in the wall and mostly consist of **basalts**. Some of these lavas are **vesicular** (where small bubbles of volcanic gases were trapped in the fast-cooling rocks). Others contain white veins of calcite (locally known as **Pocombe Lavas**).

Looking closer, you'll see that the wall also contains rounded blocks of **quartz** along with broken bricks. This really was just built out of what came to hand!
