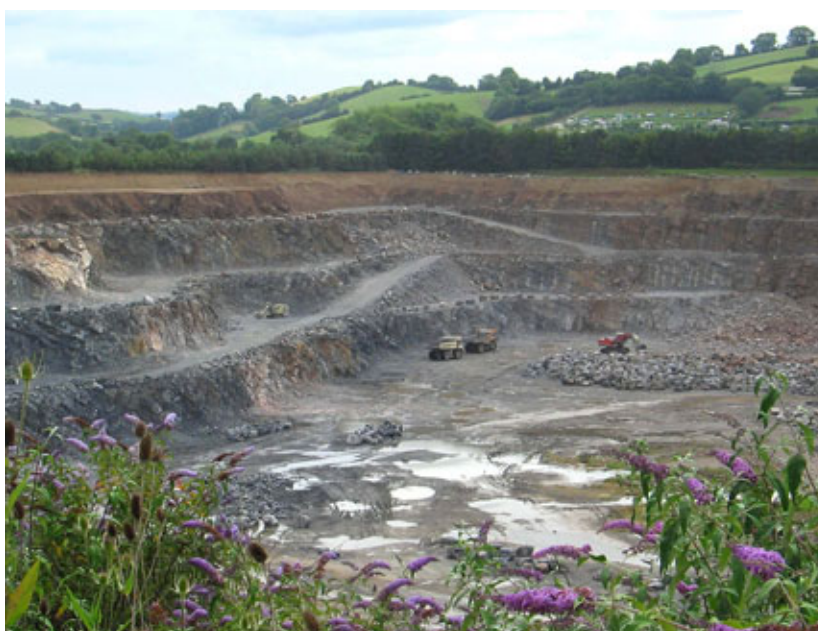
Photo LI 0.**From SX 7698 7152, elevation 130 m AOD****Facing WSW.**

General view of quarry working faces in dark to medium-grey Devonian limestone. Top face comprises soil at surface overlying poorly-sorted, brown, clayey gravel and silt above the limestone with a thin transitional zone of mixed silty-clay/limestone (see also Photo LI 10).

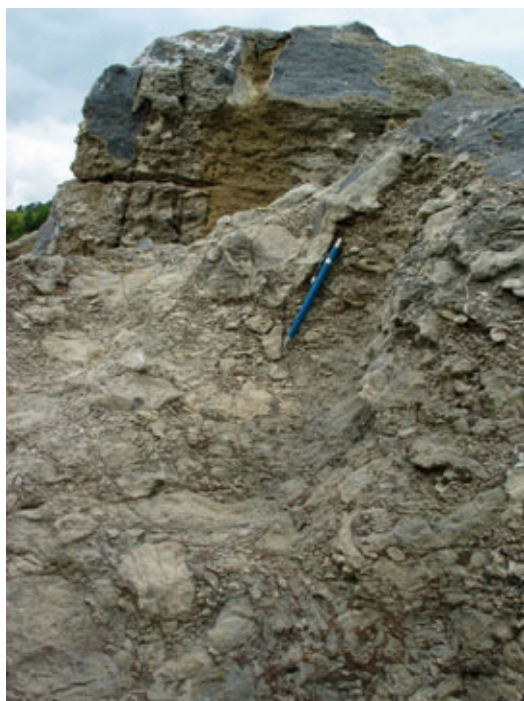
Photo LI 4**At SX 7733 7166, Elevation 130m AOD****Loose block**

Solution weathering relief and fossil corals, stromatoporoids and other shelly fossils weathered out on surface. Note that detail of fossils is not readily visible on freshly broken surfaces.

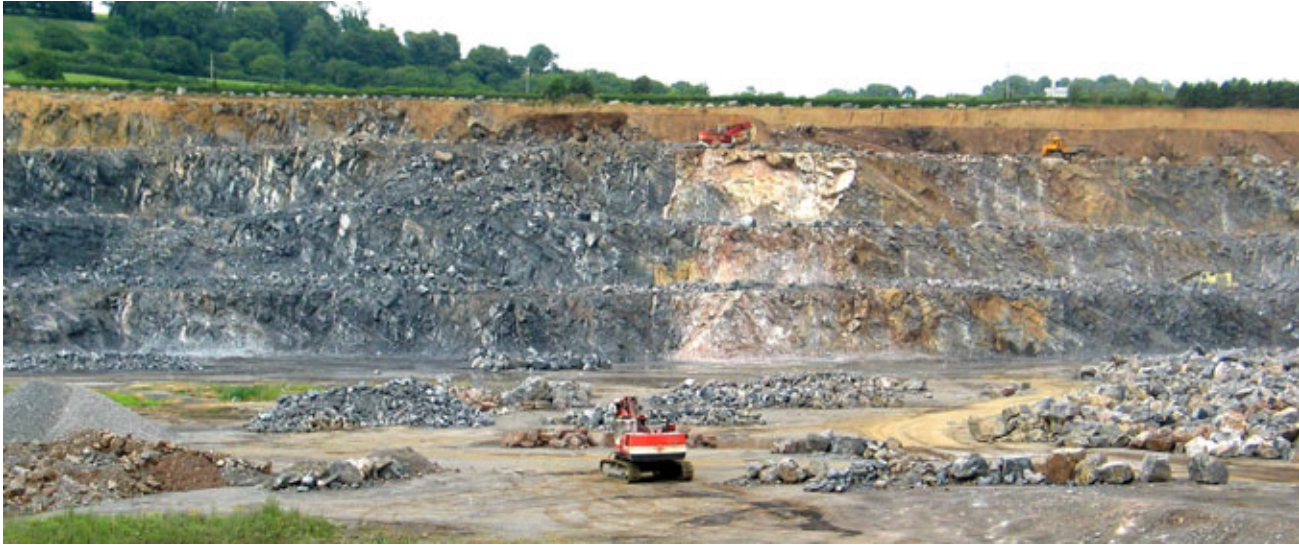
Photo LI 10**From SX 7715 7116, elevation 95 m AOD****Facing NE.**

Distant view of north-east face in dark-grey limestone dipping consistently eastwards with, at centre, a disturbed zone of white calcite replacement, possibly a fault or thrust structure parallel to the main boundary thrusts. Traces of bedding (some undisturbed, some much disturbed) appear to pass through the white calcite zone. The calcite zone appears to be a replacement feature rather than cavity infill.

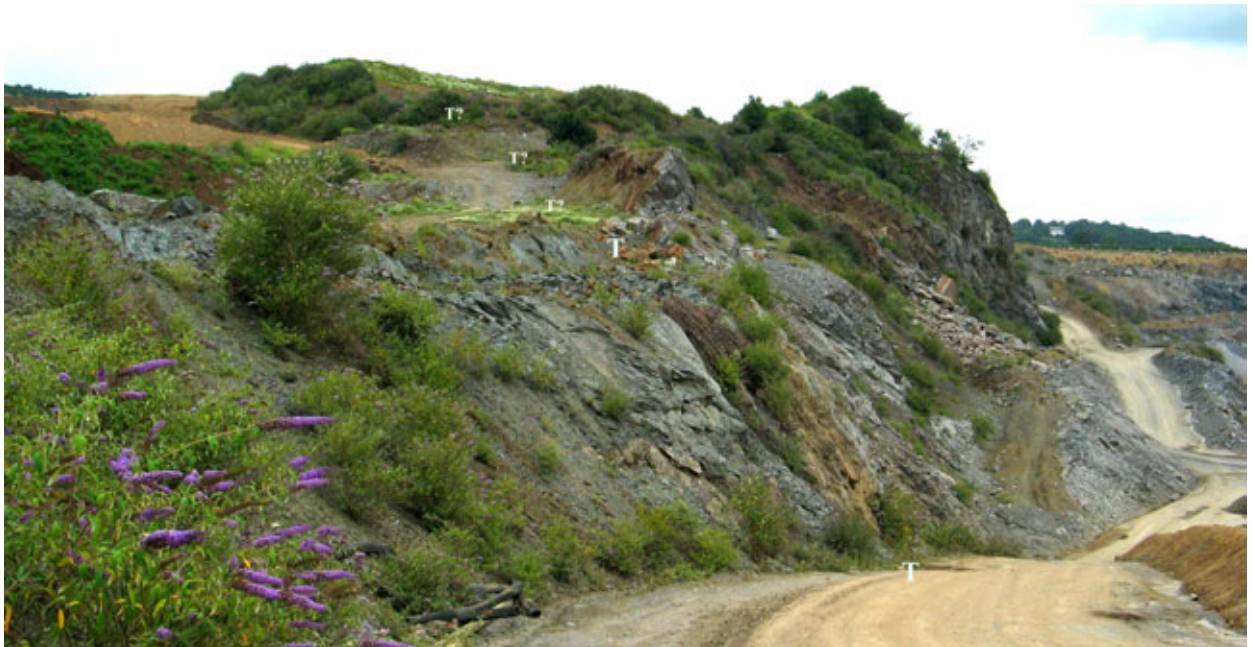
Photo LI 12**From SX 7672 7119, elevation 95 m AOD****Facing NE.**

Bickington Thrust shown T-T and probable continuation T? across unexposed ground beyond marking the contact at the northern edge of the limestone thrust against the underlying, but younger, Kate Brook Slate. Main quarry is at RH side.

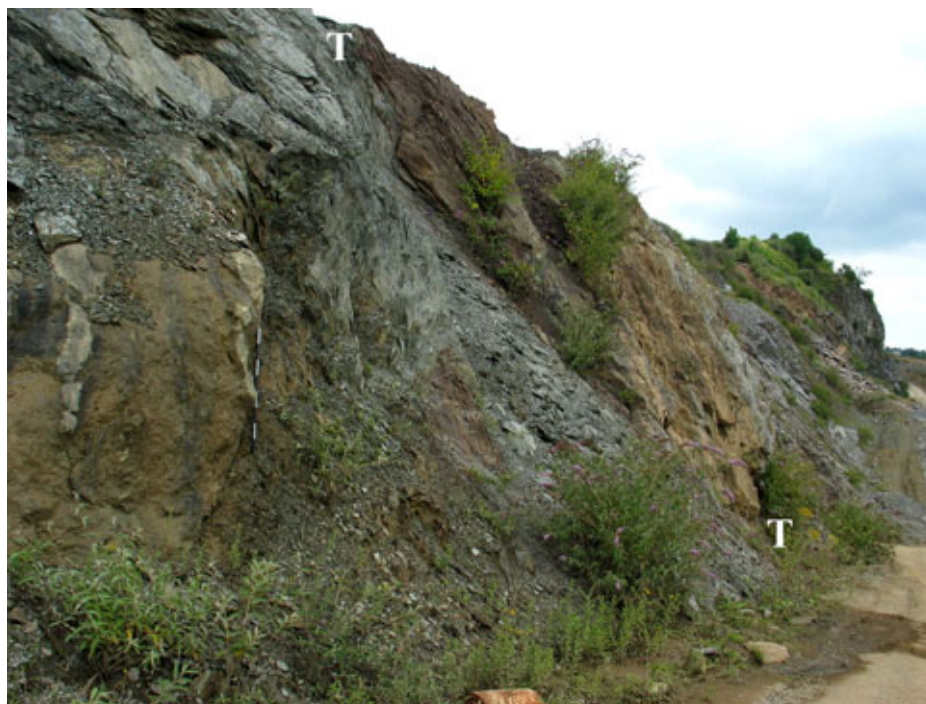
Photo LI 13

Closer view of the Bickington Thrust T-T showing complex and irregular nature of the contact of the limestone with the underlying deformed Kate Brook Slate with included rafts of other rock types at LH side.

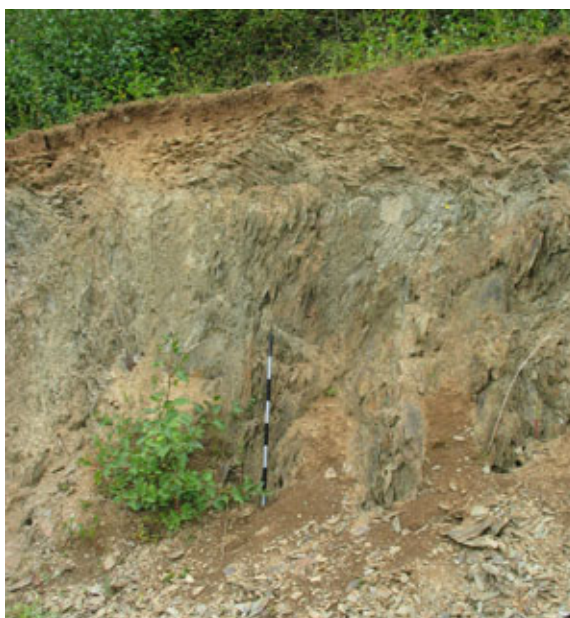
Photo LI 15

Upper Devonian Kate Brook Slate underlying the Bickington Thrust. Note bedding is indistinct and prominent near-vertical cleavage, strike 088° (near east-west). Scale marker in 10 cm divisions.
