**A380 South Devon Link Road (Kingskerswell Bypass)**

**Public Inquiry**

**Devon County Council's Response to  
Proof of Evidence on behalf of Three Corner Plantation Limited**

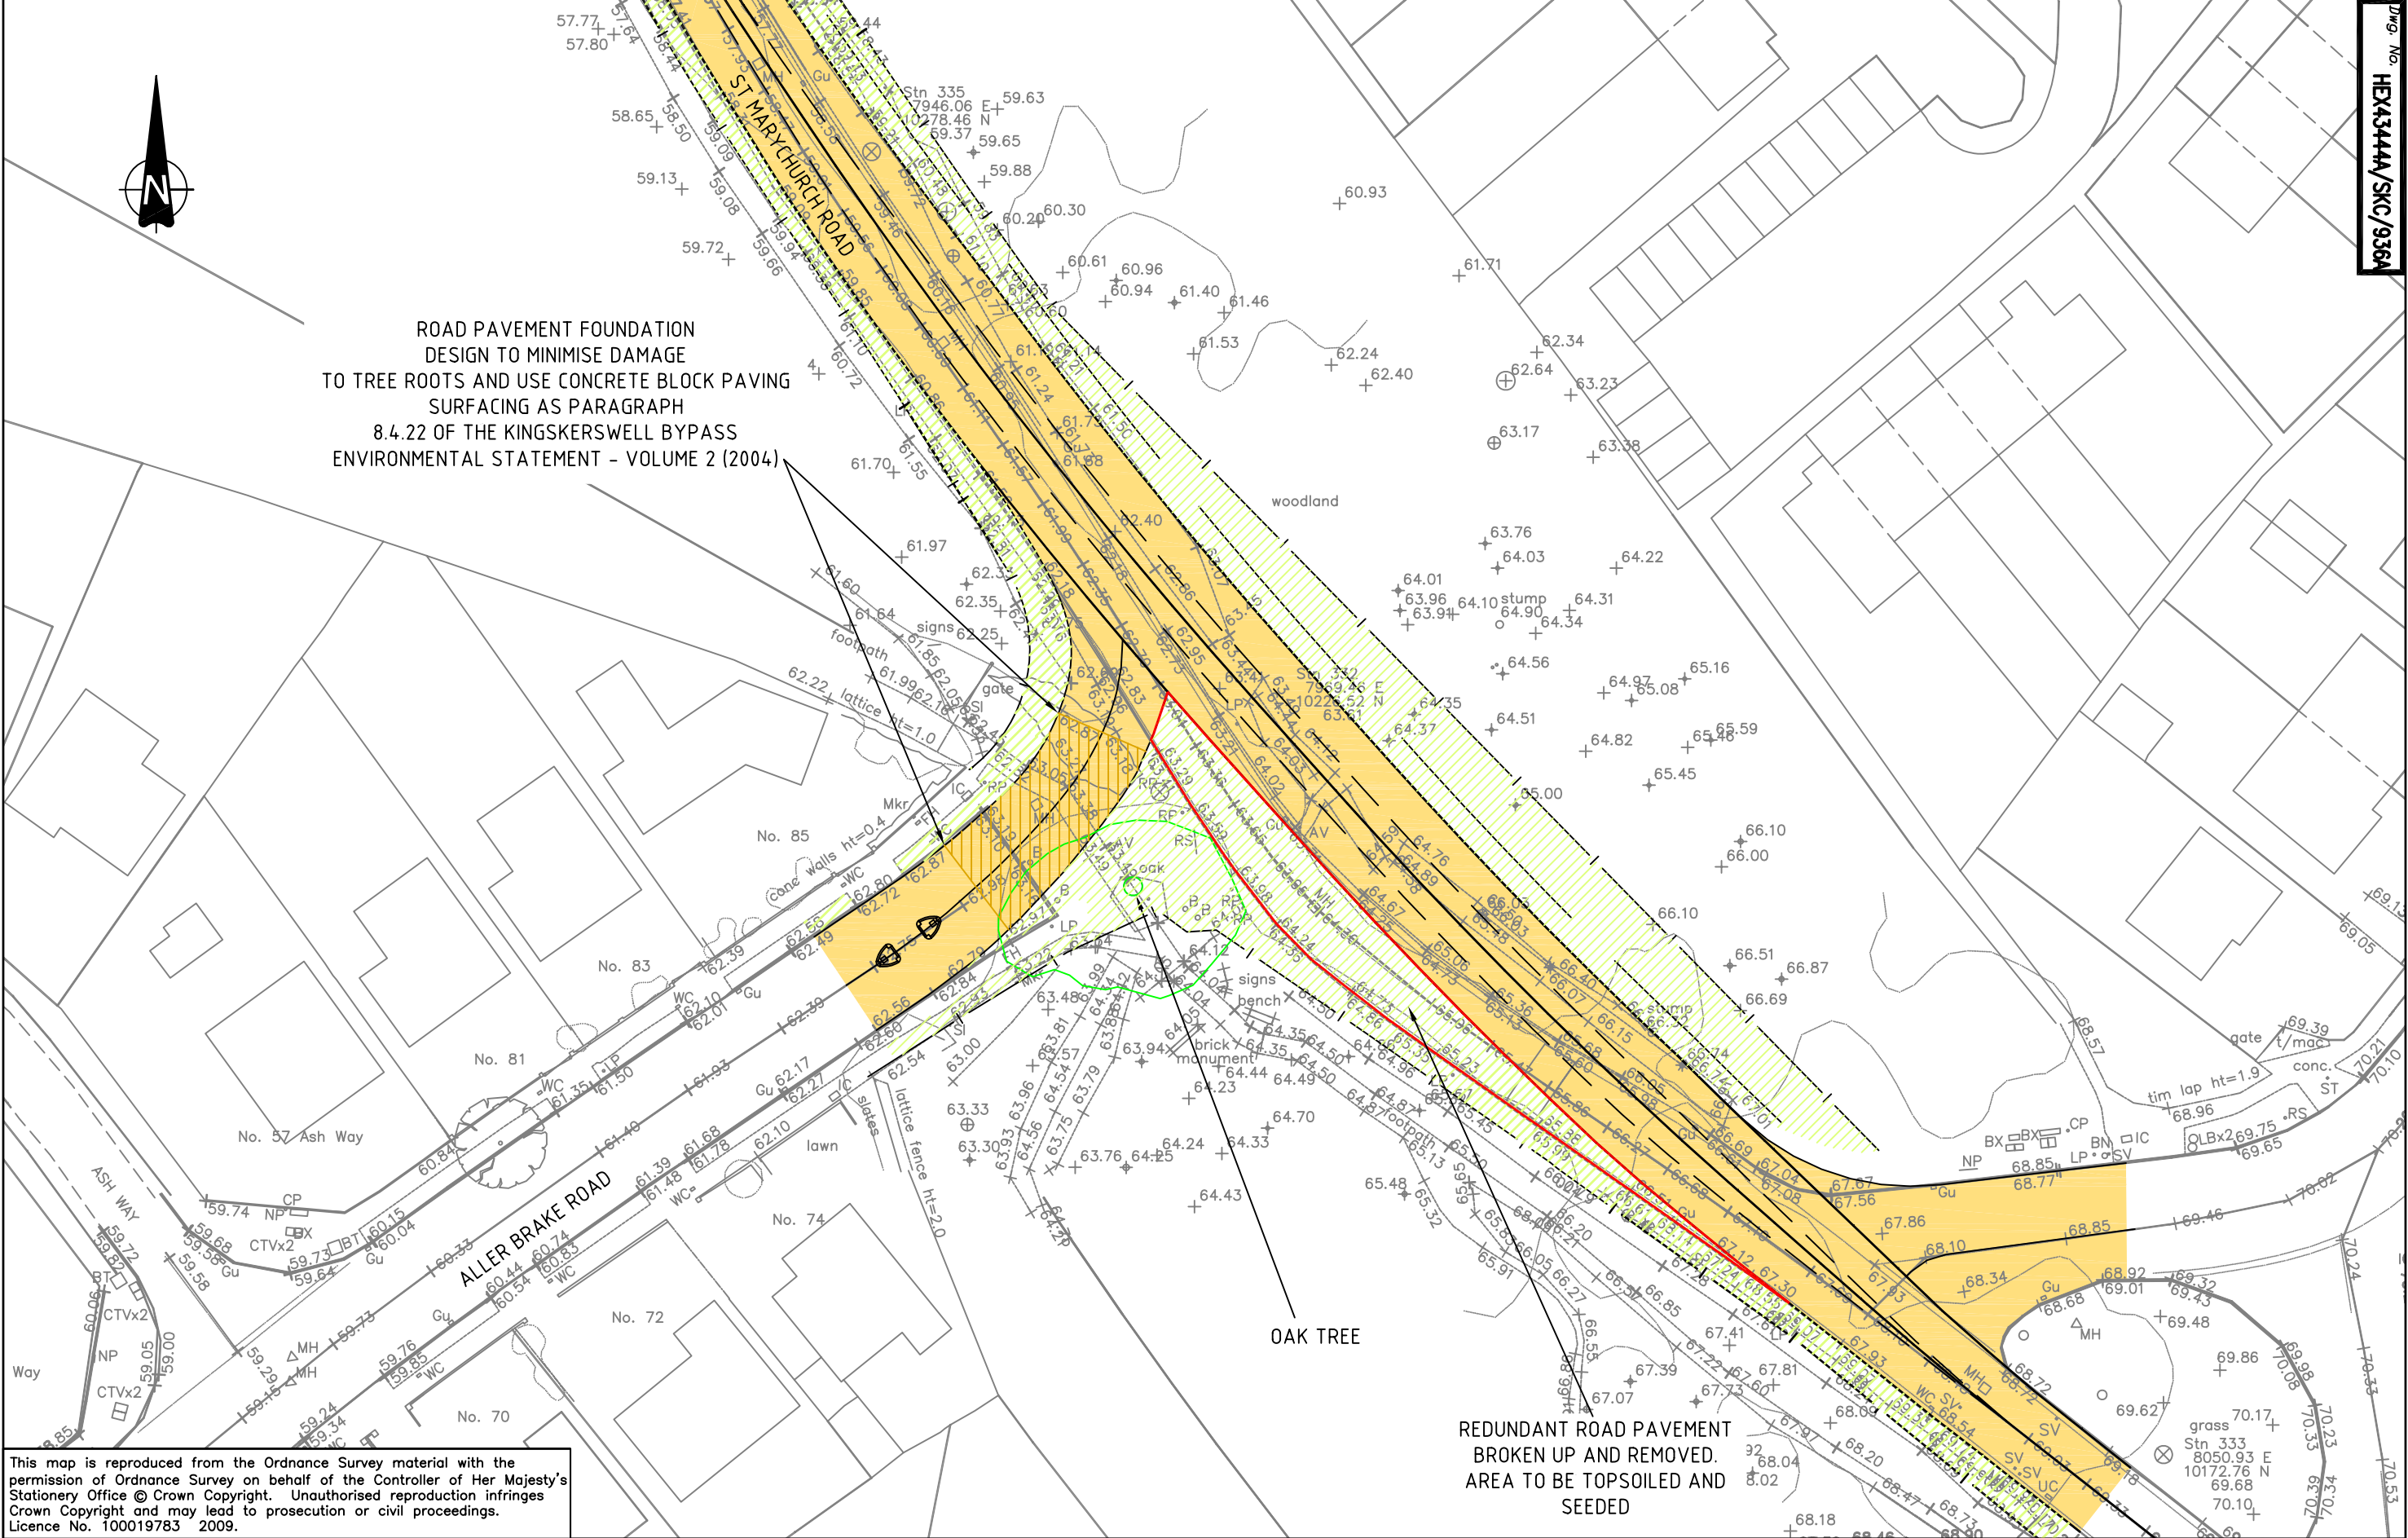
**Drawing HEX43444A/SKC/936A**

ROAD PAVEMENT FOUNDATION  
 DESIGN TO MINIMISE DAMAGE  
 TO TREE ROOTS AND USE CONCRETE BLOCK PAVING  
 SURFACING AS PARAGRAPH  
 8.4.22 OF THE KINGSKERSWELL BYPASS  
 ENVIRONMENTAL STATEMENT - VOLUME 2 (2004)

REDUNDANT ROAD PAVEMENT  
 BROKEN UP AND REMOVED.  
 AREA TO BE TOPSOILED AND  
 SEED

No.	Date	Revisions
A	26/06/09	LIMITS OF ROAD PAVEMENTS SHOWN

- *It is proposed to install a standard highway but with a permeable surface. If the trees root system does occupy the ground under the road then water will be able to percolate to the underlying ground. This is an additional measure that may enhance the ground conditions for the tree and be more favourable for root growth."*
